State of Nevada
Office of Military / Nevada National Guard
Floyd Edsall Training Center
Facility Condition Analysis

FLOYD EDSALL TRAINING CENTER

Site Number: 9879
STATE OF NEVADA PUBLIC WORKS DIVISION
FACILITY CONDITION ANALYSIS

Report Printed in April 2013

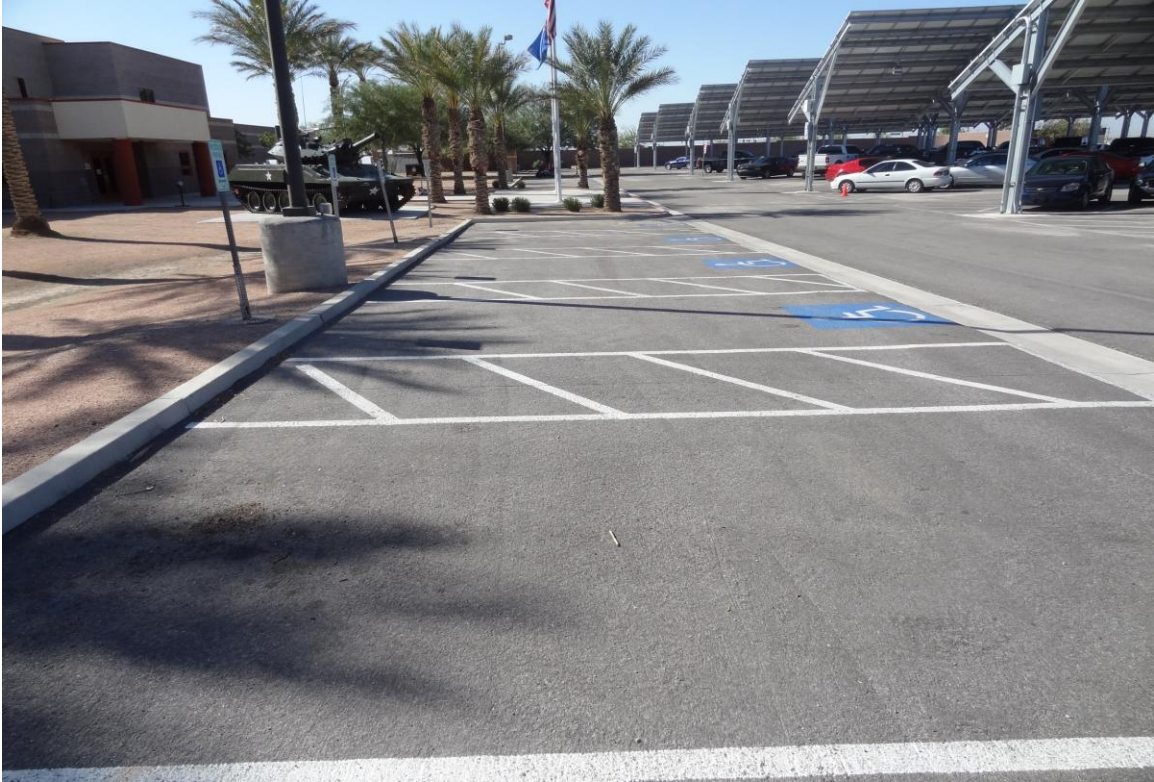
Floyd Edsall Training Center Site – FCA Site #9879
Description: ADA accessible parking area.

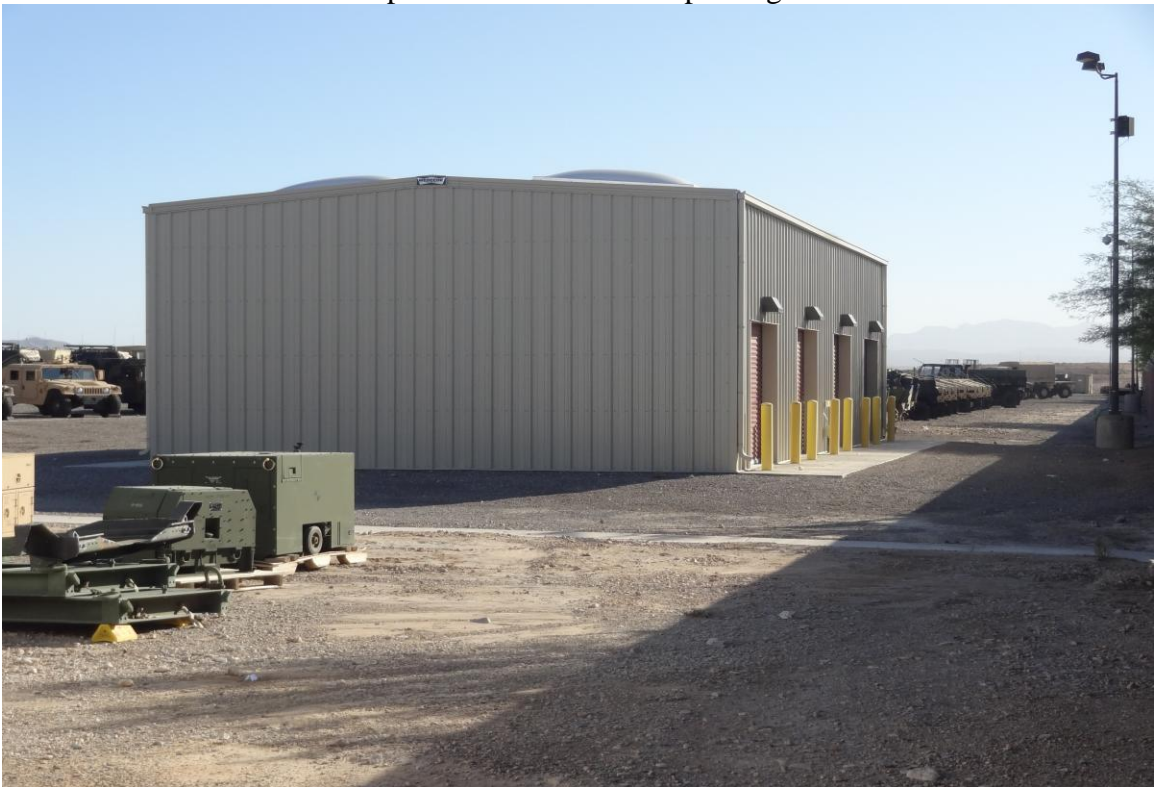
The FETC storage Building is an engineered steel structure which has 4 individual storage bays. It has a concrete slab on grade foundation and is in excellent shape.

FETC Storage Building – FCA Building #3158
Description: Exterior of the building.

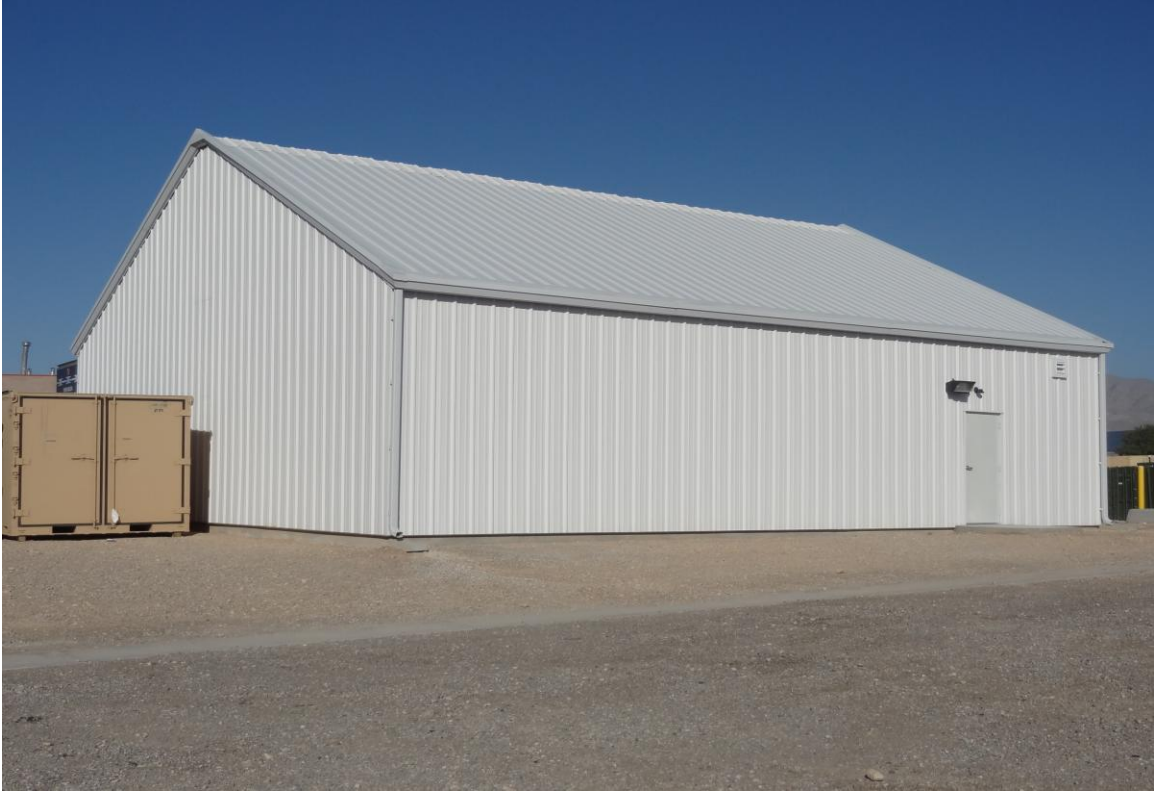
The FETC Virtual Training Facility is an engineered steel structure on a concrete slab on grade foundation. The building is in excellent shape.

FETC Virtual Training Building – FCA Building #3157
Description: Exterior of the building.

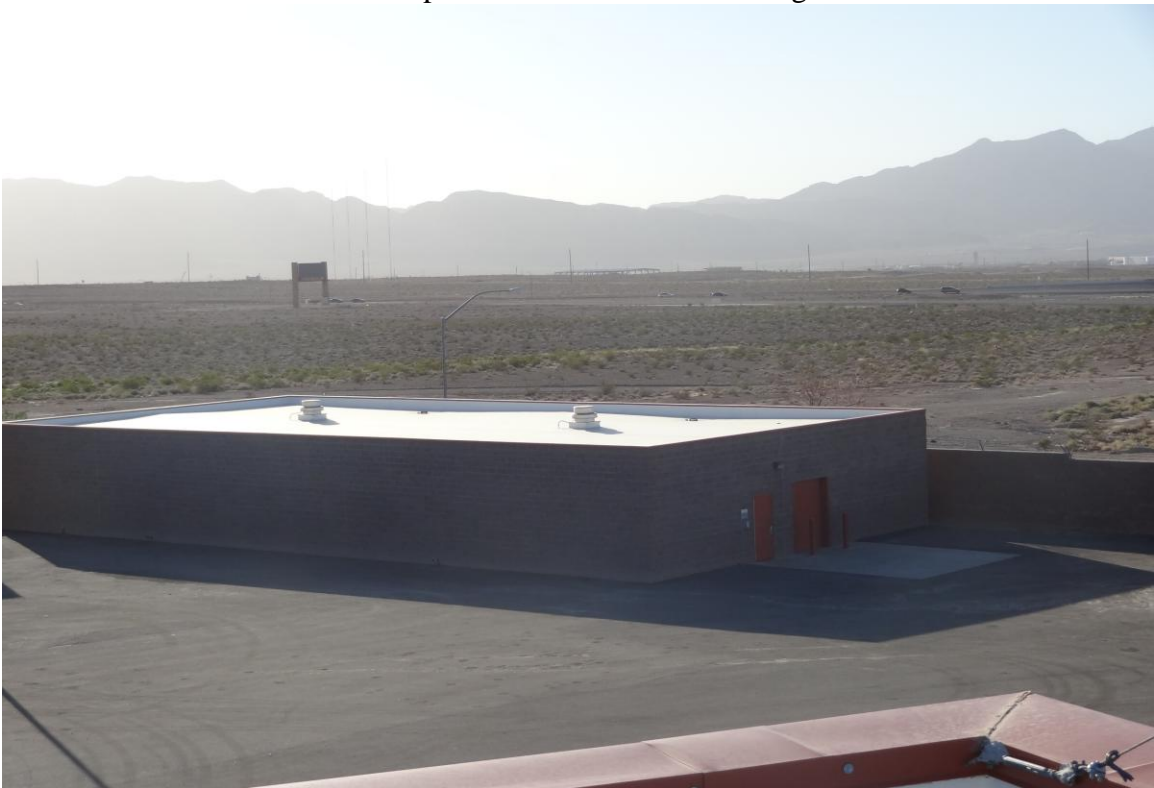
The United States Fiscal and Property Office Warehouse (USFPO) for the Nevada National Guard consists of storage space for equipment. The building is constructed of concrete masonry units with a single-ply membrane roof. The building is in good condition.

FETC USFPO Warehouse – FCA Building #2023
Description: Exterior of the building.

It is important to maintain the finish, weather resistance and appearance of the building. This project would provide funding to protect the exterior of the building excluding the roof. Included in the cost are cleaning and sealing the concrete masonry units, painting the metal trim and caulking of the flashing, fixtures and all other penetrations. It is recommended that the building be sealed and caulked in the next 2-3 years and that this project be scheduled on a cyclical basis to maintain the integrity of the structure.

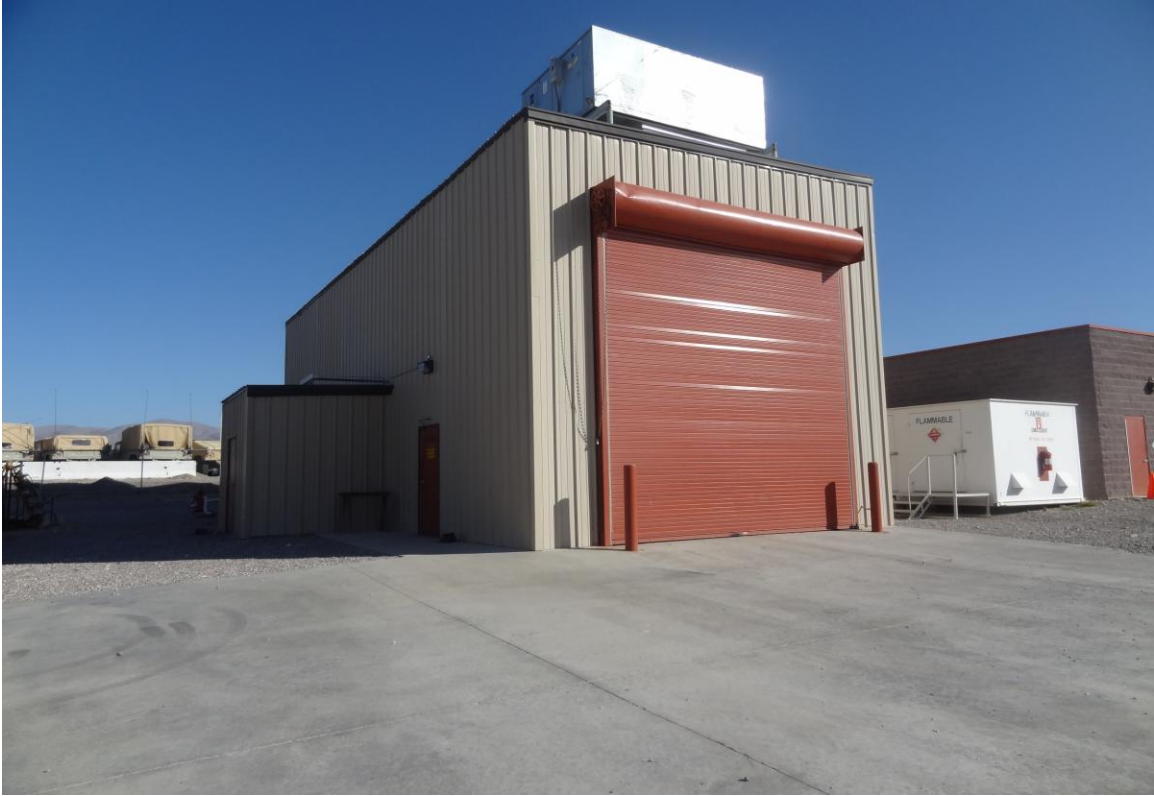
The Paint Booth is an engineered steel structure with a single-ply membrane roofing system on a concrete foundation. The building is used for the preparation and painting of National Guard vehicles and equipment. The facility is in good condition.

FETC Paint Booth – FCA Building #1964
Description: Exterior of the building.

It is important to maintain the finish, weather resistance and appearance of the building. This project would provide funding to protect the exterior of the building excluding the roof. Included in the cost is the caulking and sealing of the flashing, fixtures and all other penetrations. It is recommended that the building be caulked and sealed in the next 3-4 years and that this project be scheduled on a cyclical basis to maintain the integrity of the structure.

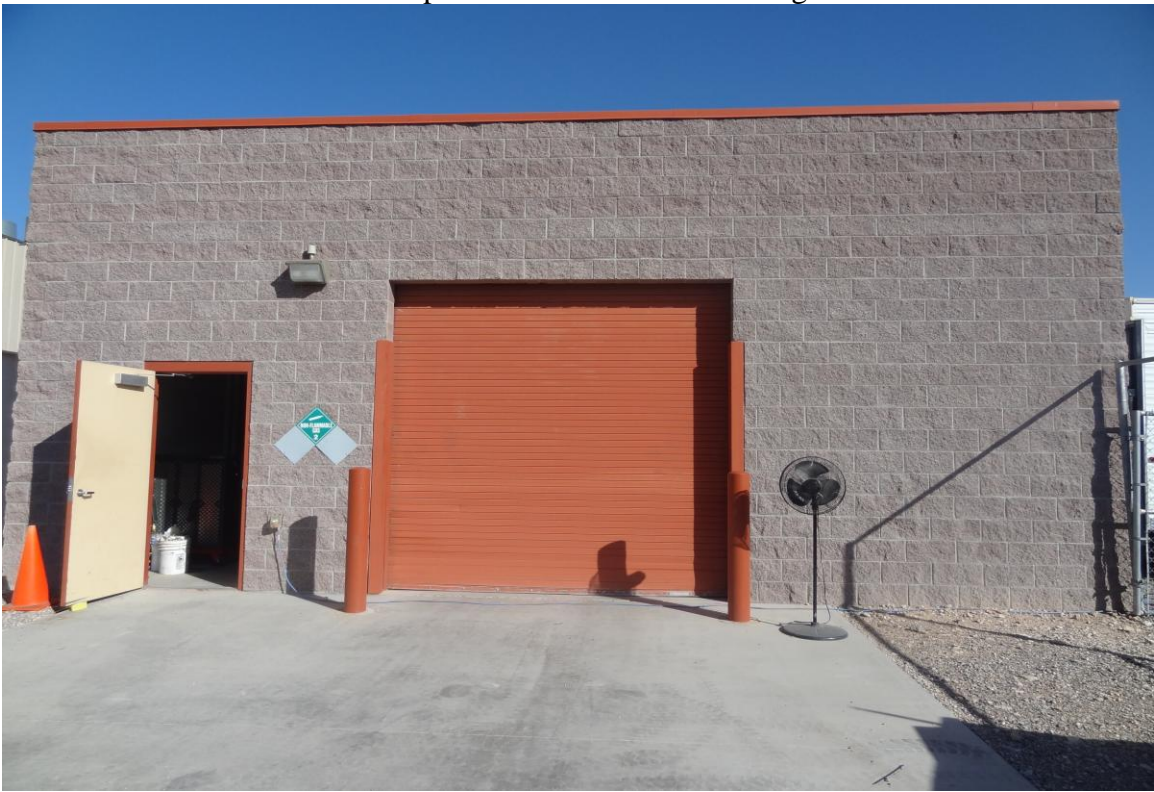
The CSMS Storage Building is constructed of concrete masonry units, concrete foundation and structural steel roof trusses covered by a single-ply roof membrane system. This facility is primarily used for storage. It is located adjacent to the paint booth and is in excellent condition.

FETC CSMS Storage Building – FCA Building #1963
Description: Exterior of the building.

It is important to maintain the finish, weather resistance and appearance of the building. This project would provide funding to protect the exterior of the building excluding the roof. Included in the cost are cleaning and sealing the concrete masonry units, painting the metal trim and caulking of the flashing, fixtures and all other penetrations. It is recommended that the building be sealed and caulked in the next 2-3 years and that this project be scheduled on a cyclical basis to maintain the integrity of the structure.

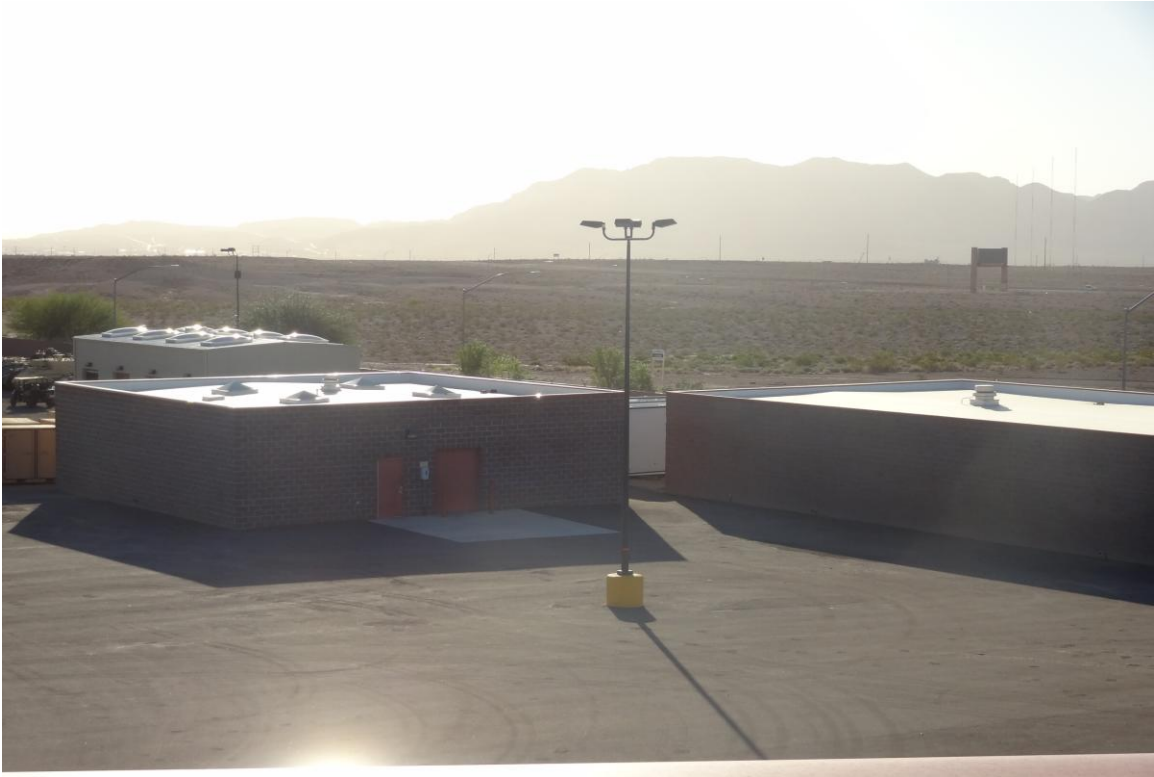
The Armory Storage Building is constructed of concrete masonry units, concrete foundation and steel roof trusses covered by a single-ply roof membrane system. This facility is primarily used for storage of extra material for the Nevada National Guard Units.

FETC Armory Storage Building – FCA Building #1962
Description: Exterior of the building (on left).

It is important to maintain the finish, weather resistance and appearance of the building. This project would provide funding to protect the exterior of the building excluding the roof. Included in the cost are cleaning and sealing the concrete masonry units, painting the metal trim and caulking of the flashing, fixtures and all other penetrations. It is recommended that the building be sealed and caulked in the next 2-3 years and that this project be scheduled on a cyclical basis to maintain the integrity of the structure.

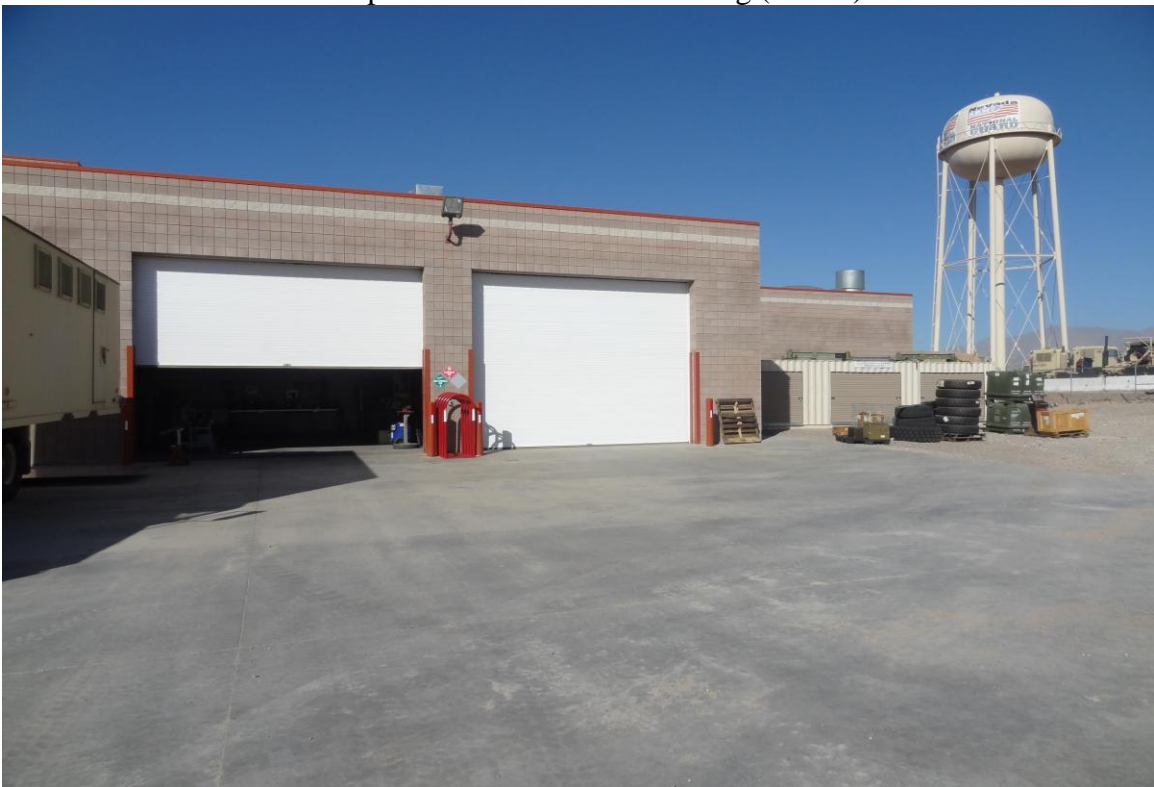
The CSMS Building is constructed of concrete masonry units, concrete foundation and steel roof trusses covered by a single-ply roof membrane system. This facility is primarily used for servicing and repairing military vehicles and weapon systems calibration. Support offices are also contained within the building.

FETC CSMS– FCA Building #1961
Description: Exterior of the building.

It is important to maintain the finish, weather resistance and appearance of the building. This project would provide funding to protect the exterior of the building excluding the roof. Included in the cost are cleaning and sealing the concrete masonry units, painting the metal trim and caulking of the windows, flashing, fixtures and all other penetrations. It is recommended that the building be sealed and caulked in the next 2-3 years and that this project be scheduled on a cyclical basis to maintain the integrity of the structure.

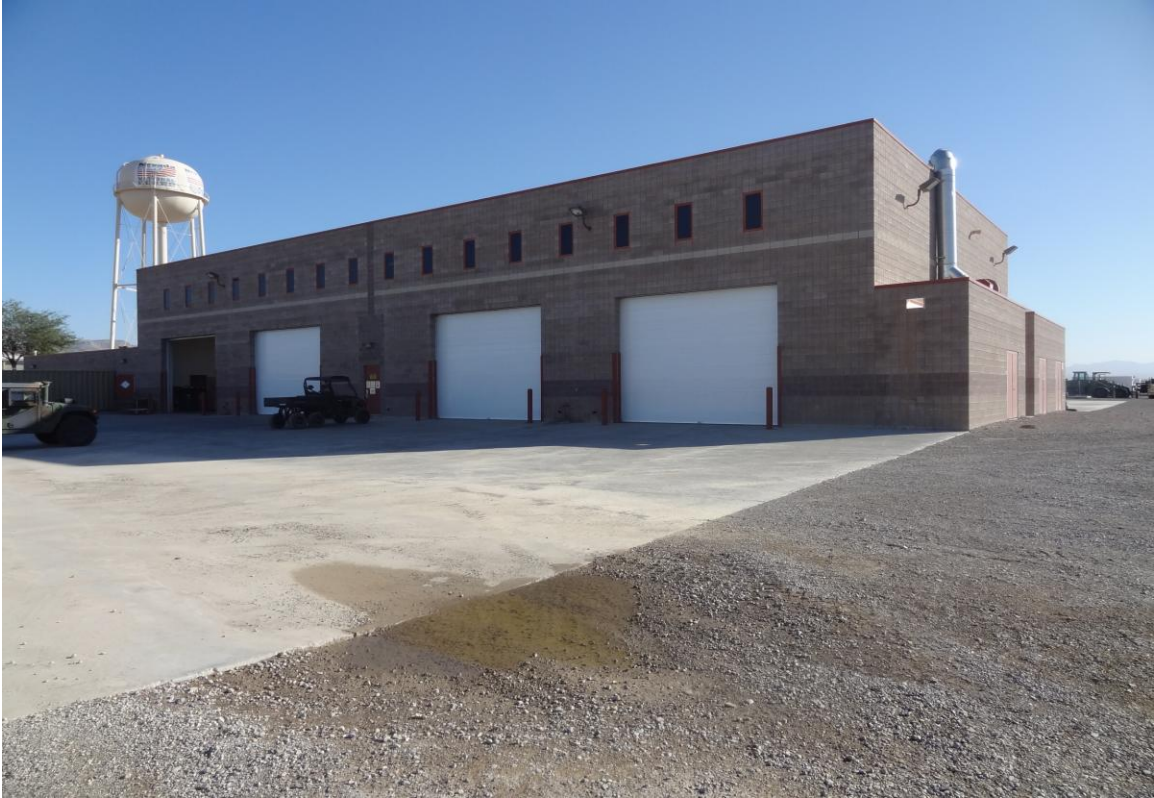
The FMS Building is constructed of concrete masonry units, concrete foundation and steel roof trusses covered by a single-ply roof membrane system. This facility is primarily used for servicing and repairing military vehicles and equipment. Support offices and restrooms are also contained within the building. The heating and cooling is provided by roof mounted evaporative coolers and radiant heating units. The facility has a fire alarm and sprinkler system.

FETC FMS Building – FCA Building #1960
Description: Exterior of the building.

It is important to maintain the finish, weather resistance and appearance of the building. This project would provide funding to protect the exterior of the building excluding the roof. Included in the cost are cleaning and sealing the concrete masonry units, painting of the metal trim and caulking of the windows, flashing, fixtures and all other penetrations. It is recommended that the building be sealed and caulked in the next 2-3 years and that this project be scheduled on a cyclical basis to maintain the integrity of the structure.

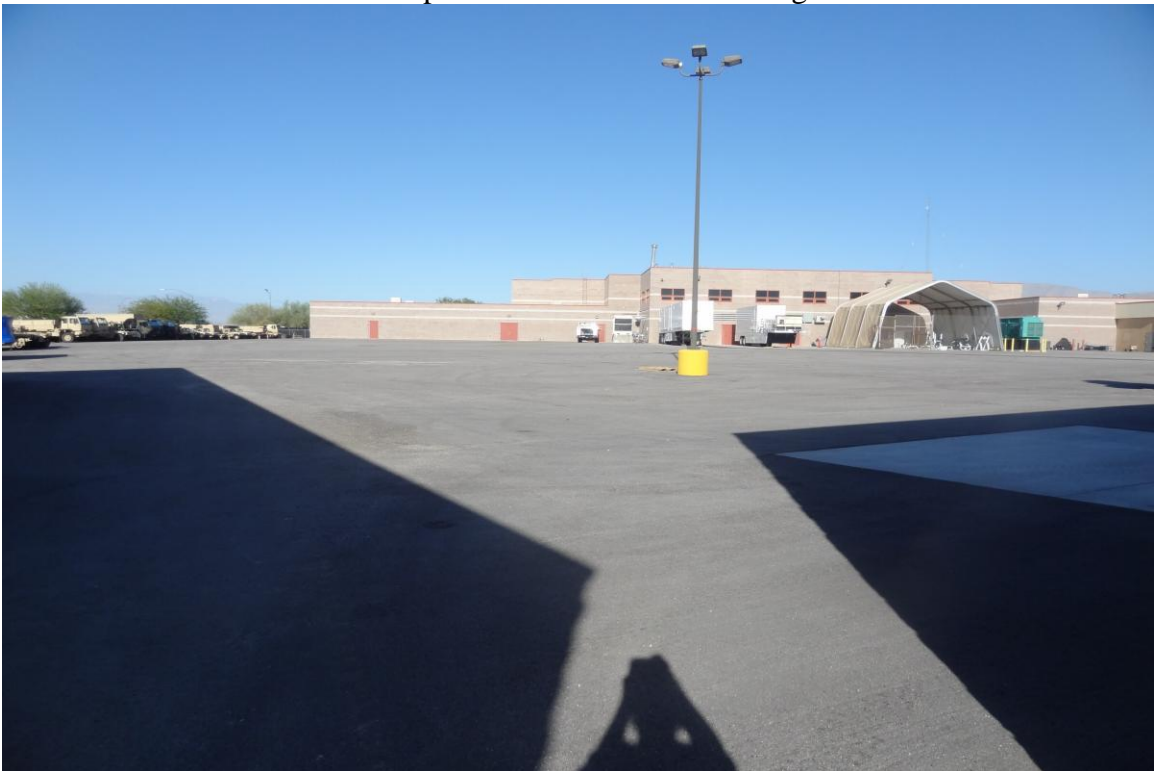
FETC Clark County Armory – FCA Building #0036
Description: Exterior of the building.

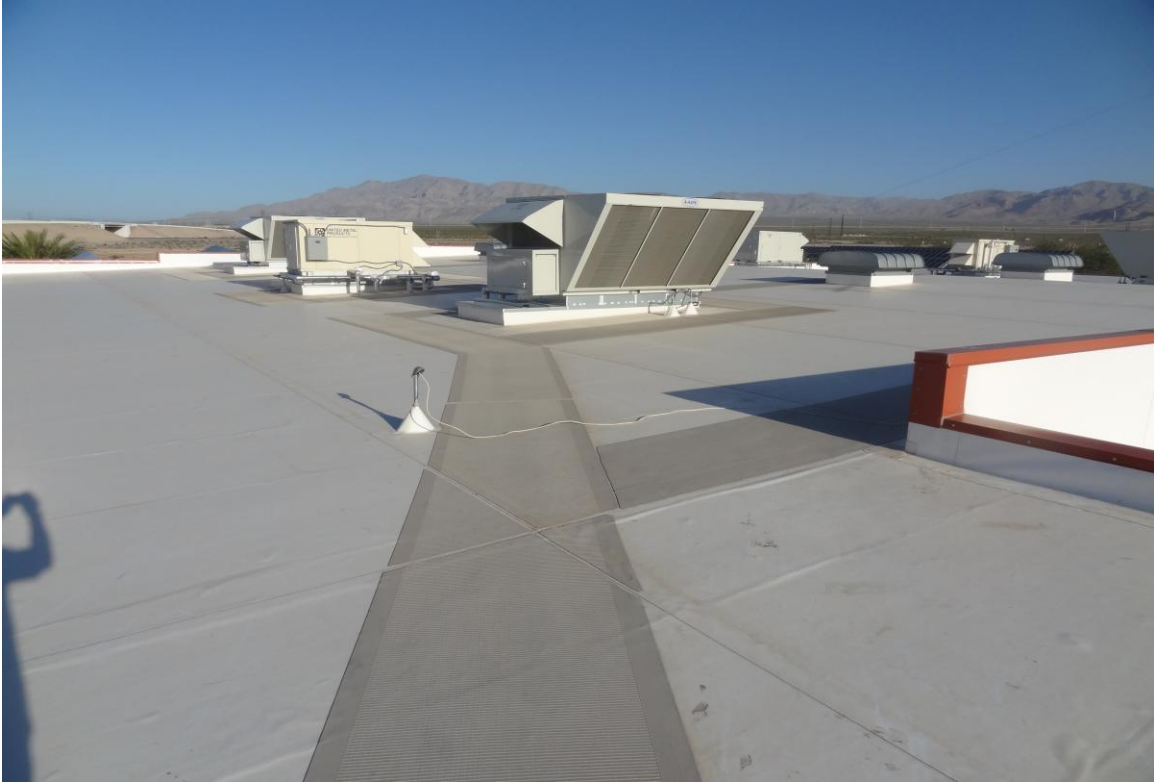
FETC Clark County Armory – FCA Building #0036
Description: Roof-top equipment.

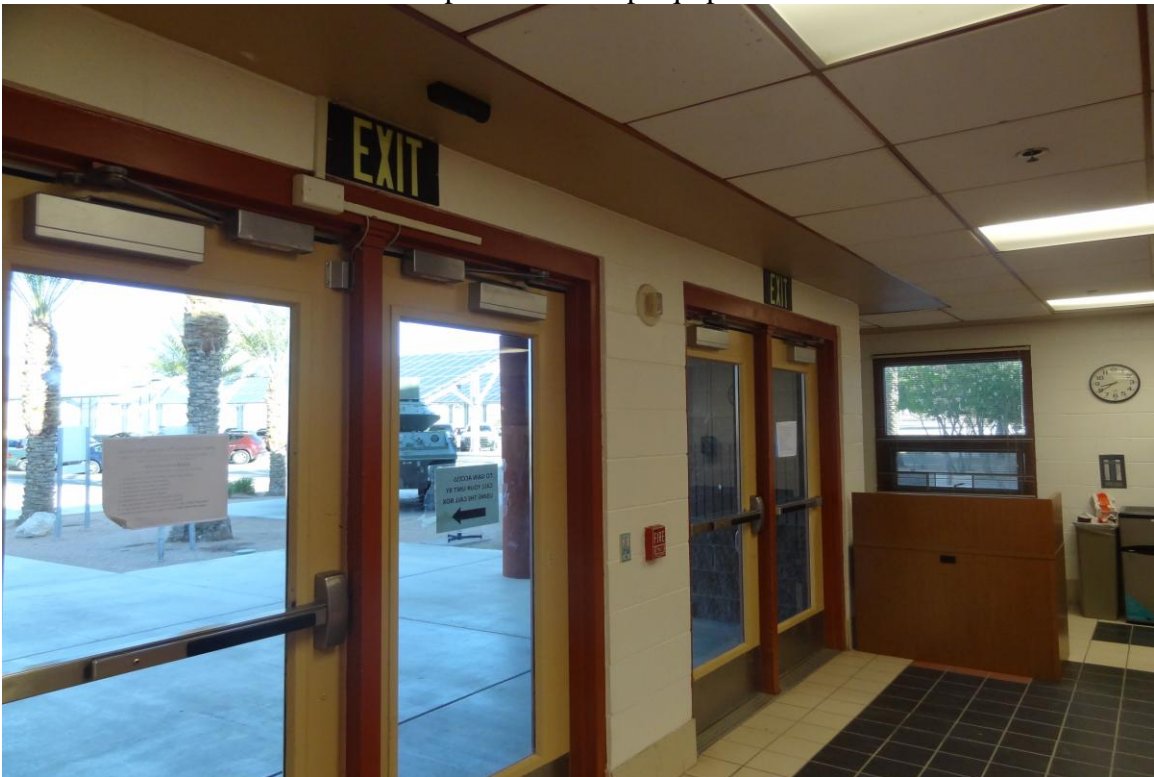
FETC Clark County Armory – FCA Building #0036
Description: Interior of the main entrance.
